H.C. Crooker had been awarded the contract to replace the water main on North St. Pipe work is scheduled to begin June 22nd at the intersection of Middle and North.

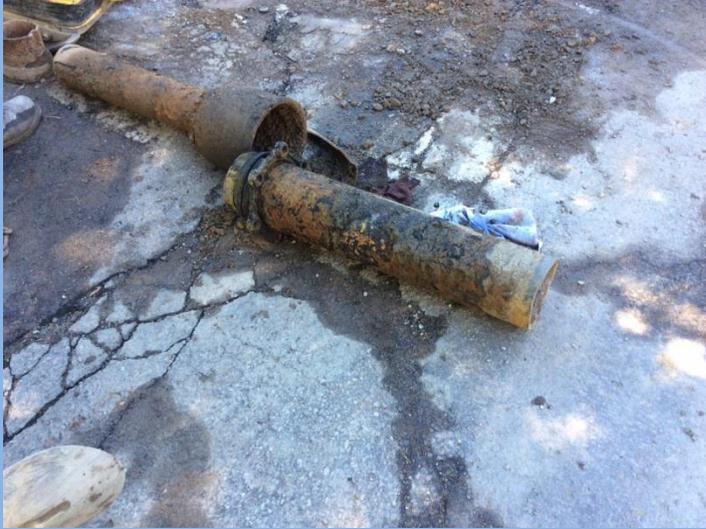
Here is a section of the old pipe being replaced.

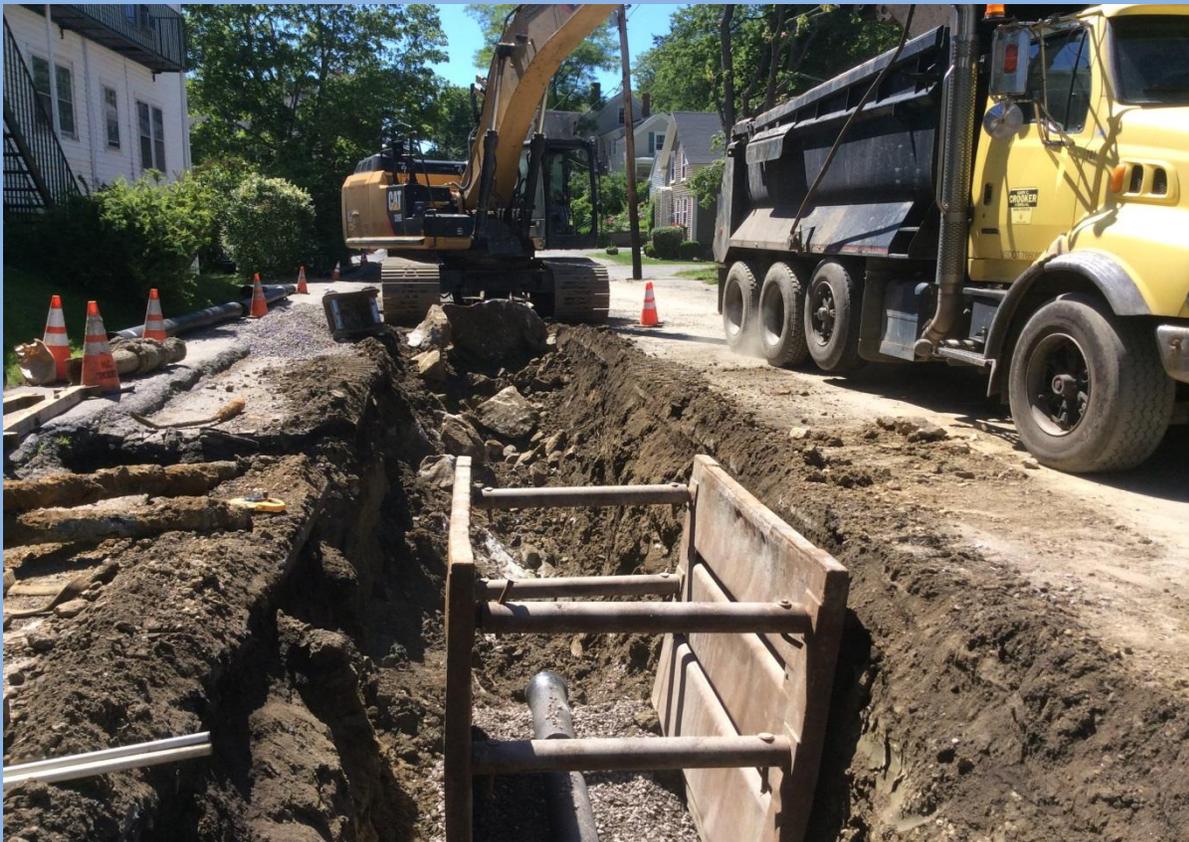
Above picture: you can see ledge being removed from the trench, a new section of pipe with a bell end in the trench box for worker safety. Old sections of removed pipe can be seen on the left.

7/2/15 The pipe section between High St. and Middle St. on North St. has been replaced and a base coat of hot top pavement is being put down. Construction will hold off now until after the 4th of July festivities.

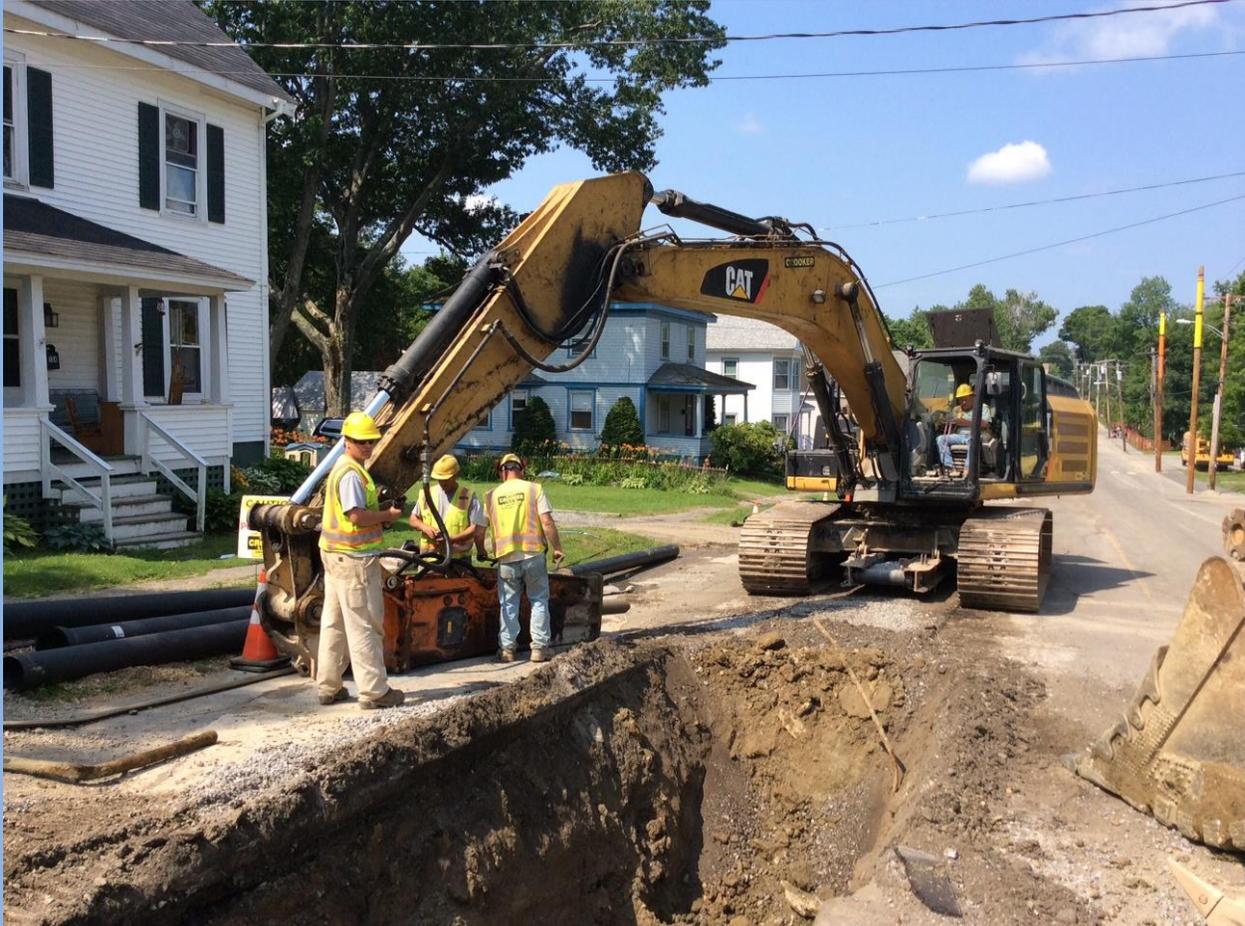
The above picture shows the Crooker Construction crew removing the rock hammer from the excavator.

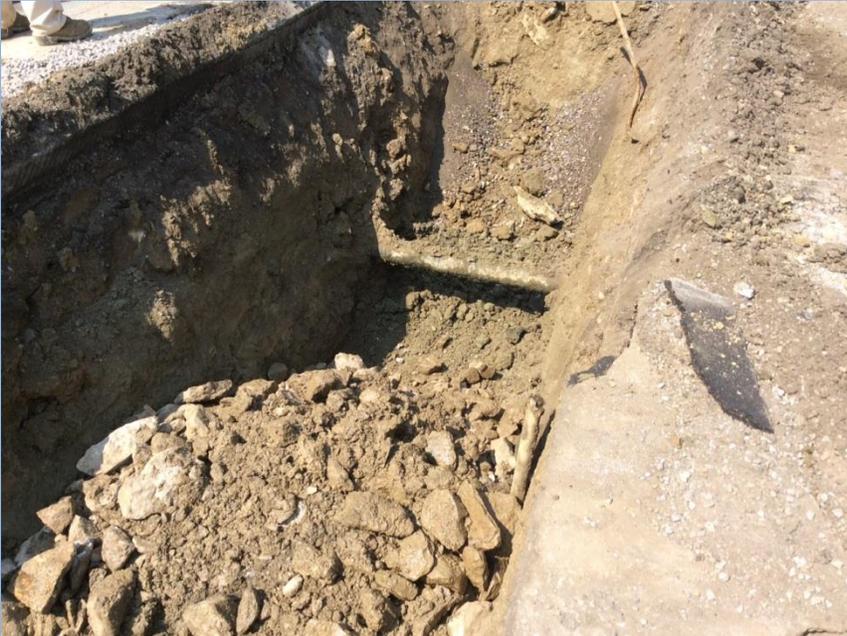
Below is chipped ledge ready to be dug out of the trench and an old pipe in the ground.

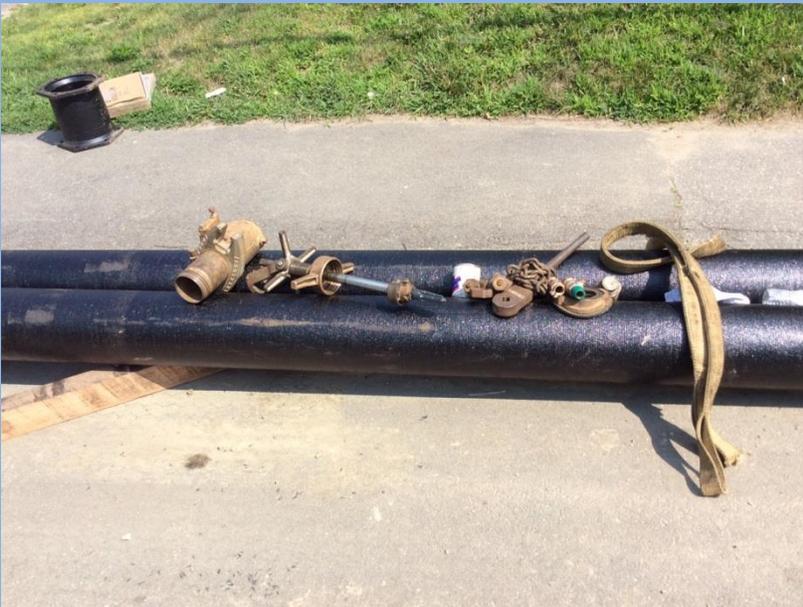
This picture shows the pipe tapping machine laid out ready to put a new service in the new main before installation.

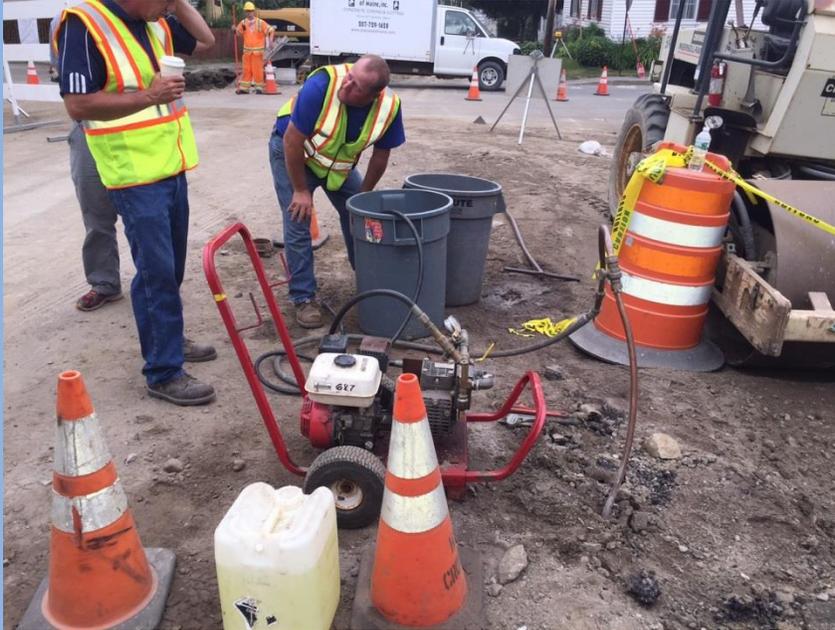
Above: Brian Moody and Bruce Gardner from BWD look over the pressure test of the new main. This is a test determining the new water pipe does not have any leaks and will hold water pressure.

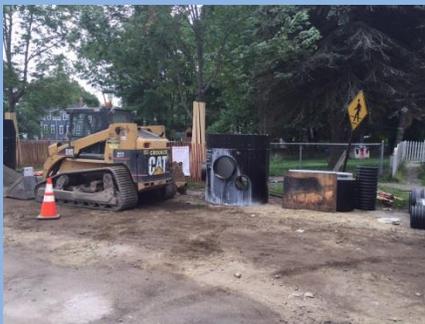
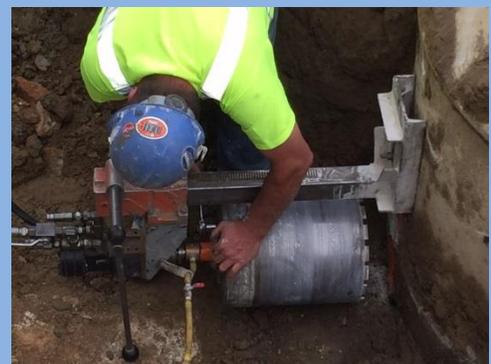
Below: A new manhole waiting to be installed. A coring machine is being mounted to an existing manhole to bore a new connection hole.

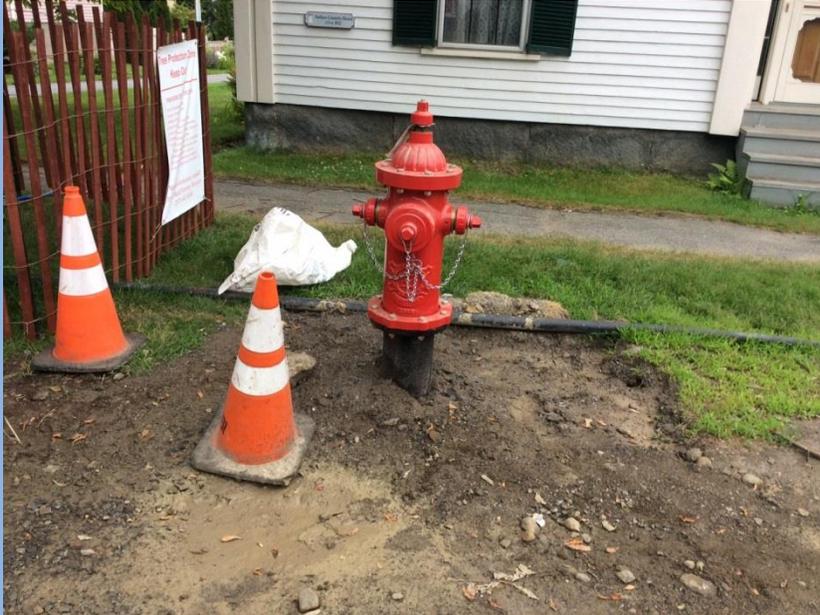
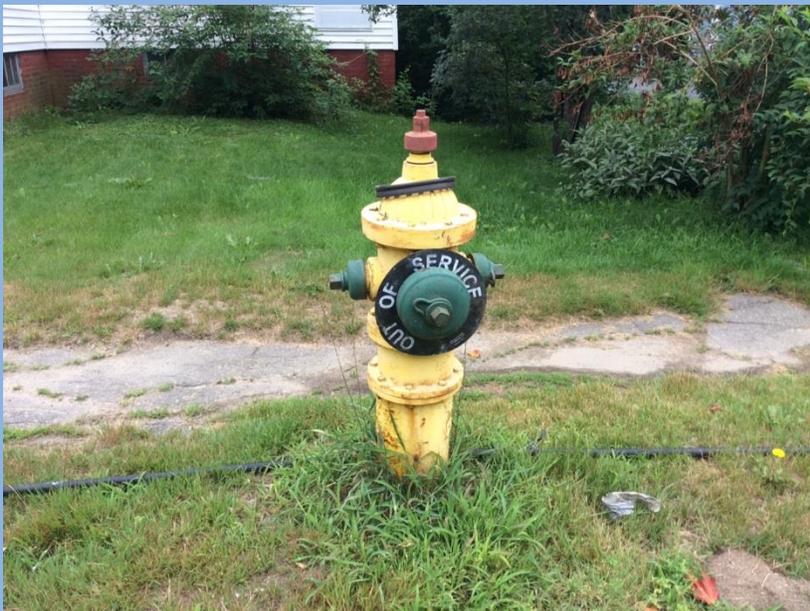
Below you can see a new hydrant installation (it will be painted yellow) and the old hydrant that will be removed after the new pipe work is finished.

The new hydrants are designed to break away at ground level when struck by vehicles and can be repaired quickly and put back into service. Old hydrant had a solid barrel and when struck in accidents often had to be dug up and completely replaced.

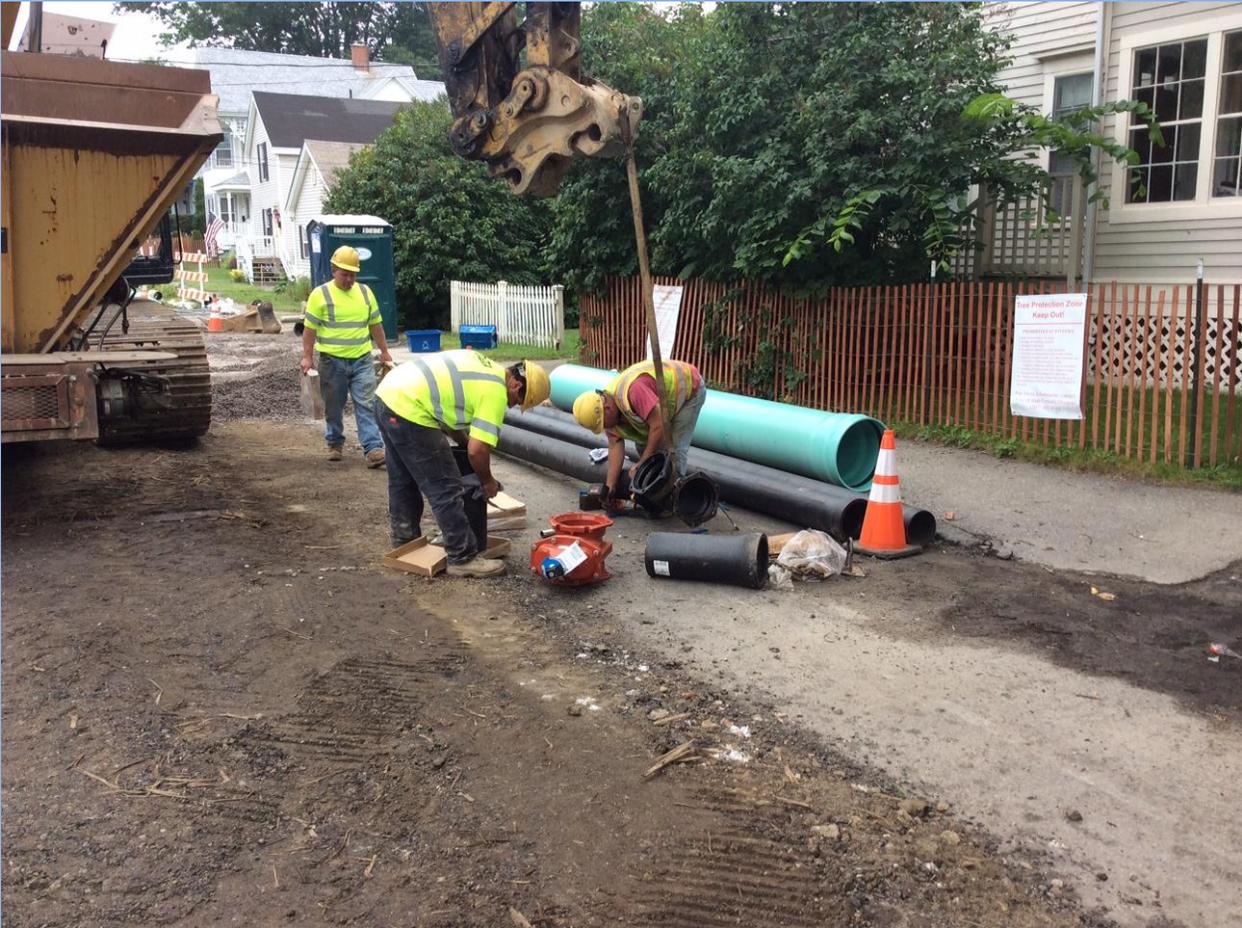
Here a new valve and tee are being bolted onto the pipe.

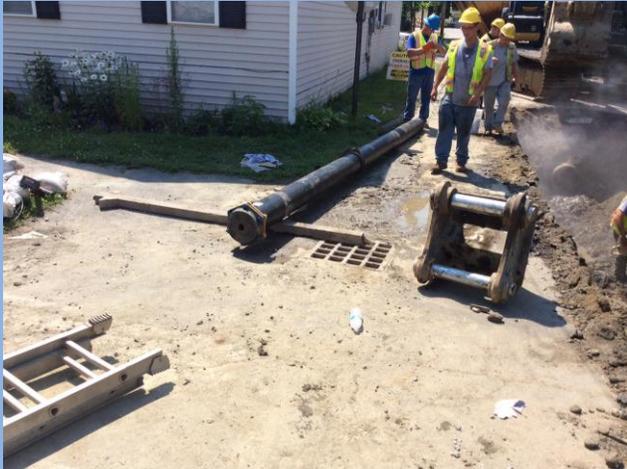
A capped stub of new pipe going in for future use on Keel St.
